## SERVICE BULLETIN LA-V75-001

Product: Underground VHF Line Amplifier

Subject: Updated “live wiring” guidelines

Date: 11<sup>th</sup> March 2021

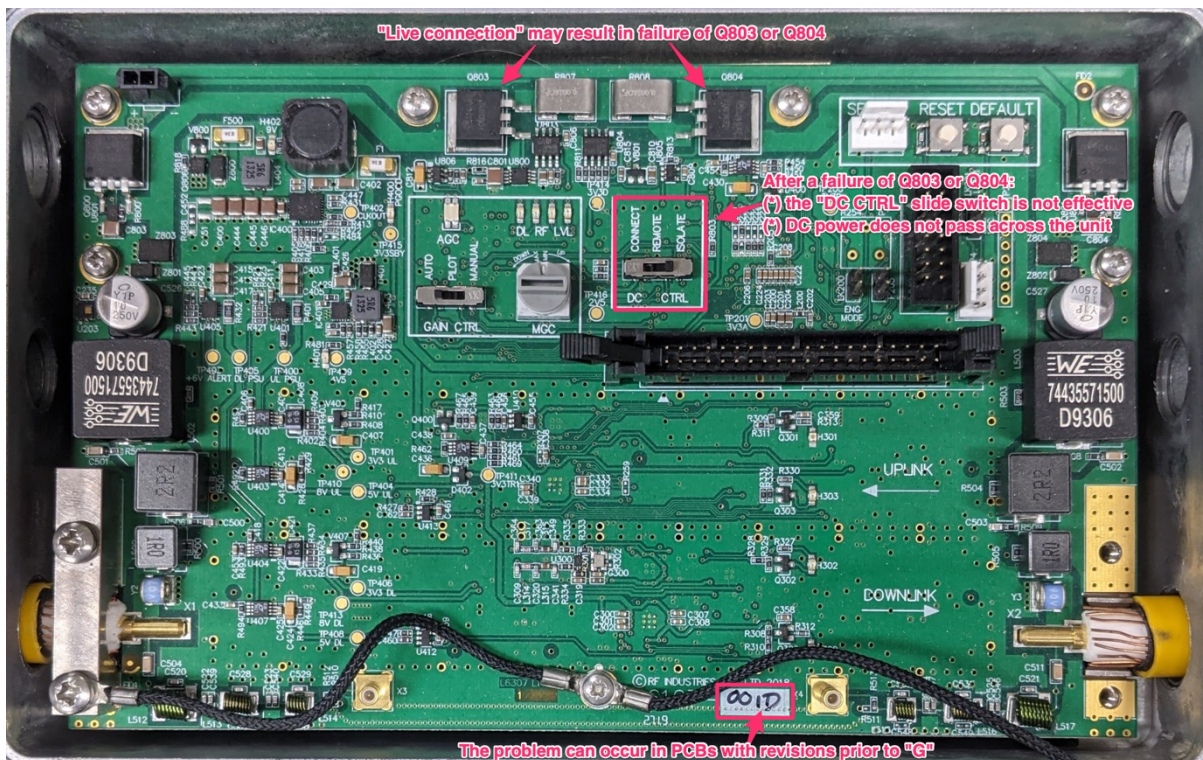
Two sites have reported failures with LineAmps after performing live connections into powered leaky feeder systems. In both instances it was found that the DC pass-through power transistor (Q803) failed. The impact on the LineAmp functionality after such a failure is:

1. The device no longer passes DC between its left and right ports;
2. The “DC CTRL” slide switch is no longer effective.

Figure 1: Illustration of the BDA PCB, highlighting the components that are affected.

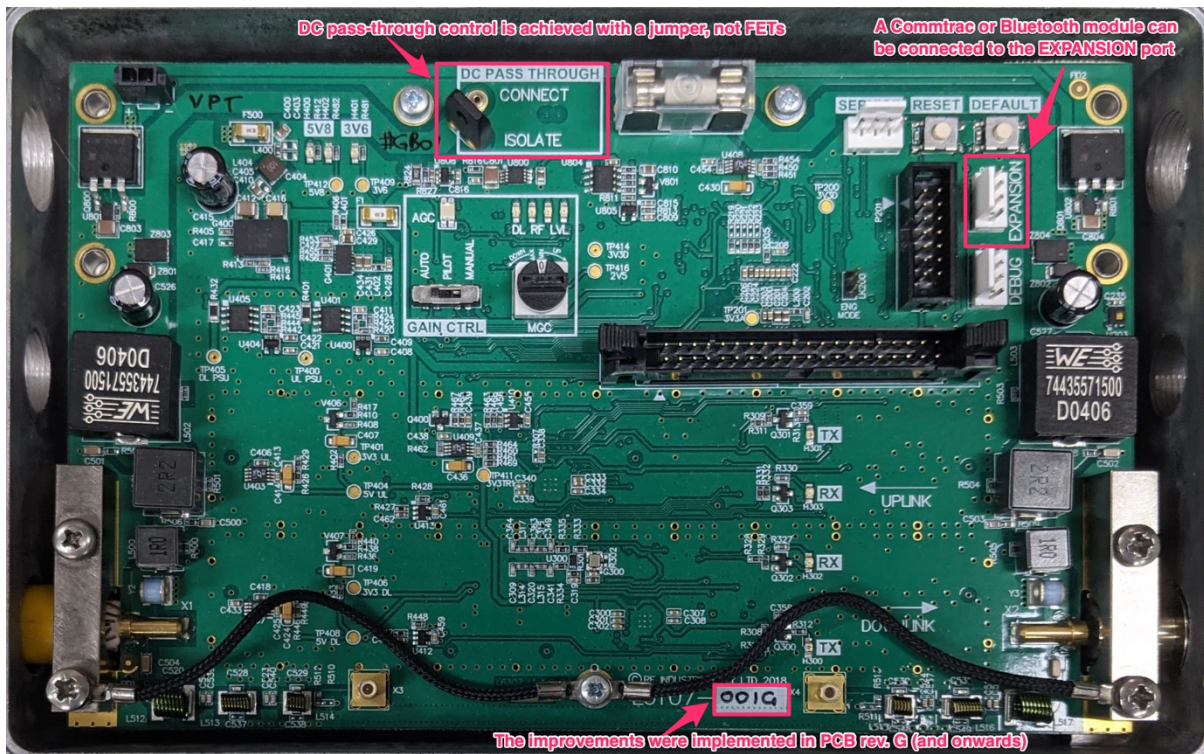
- The power pass-through transistors and “DC CTRL” slide switch being replaced by an 8A jumper link;
- 40% reduced power consumption (achieved by running the internal rails at lower voltages);
- Improved labelling of PCB controls;
- Addition of the EXPANSION port (for connection of Bluetooth or tag reading modules).

Figure 2: Illustration of the BDA PCB, highlighting the running changes implemented in mid-2020.

Due to the removal of the FETs, BDA PCBs with revision G (and onwards) do not suffer from this issue.

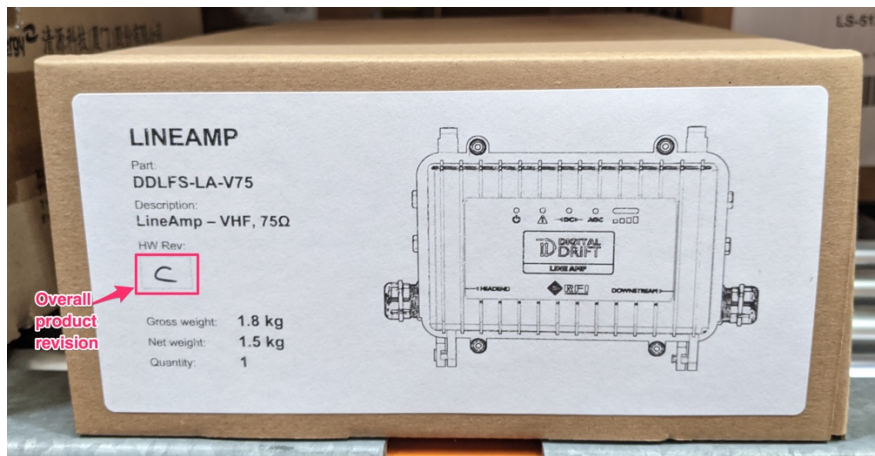
Figure 3: Outer carton, indicating the product revision

**IF:** The product revision on the outer carton is **C**, the internal device’s BDA PCB will be revision G (or greater), and the device is not affected by this issue.

**ELSE:** If the product revision on the outer carton is **A** or **B**, or if there is no label on the outer carton, then the device needs to be opened to check the PCB revision.
