# Digital Drift updates

v3.10 EoC firmware

**RFI**  
TECHNOLOGY SOLUTIONS

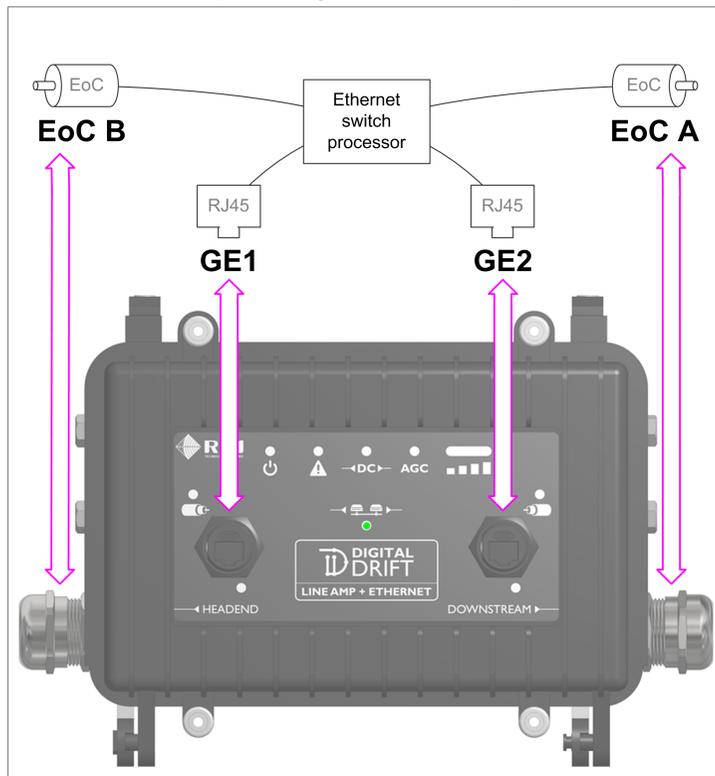
**Switch fabric combined**  
(1 x 4-port switch)

The LineAmp+Ethernet has four Ethernet ports, which can operate as a single switch fabric, or as two independent 2-port switches.

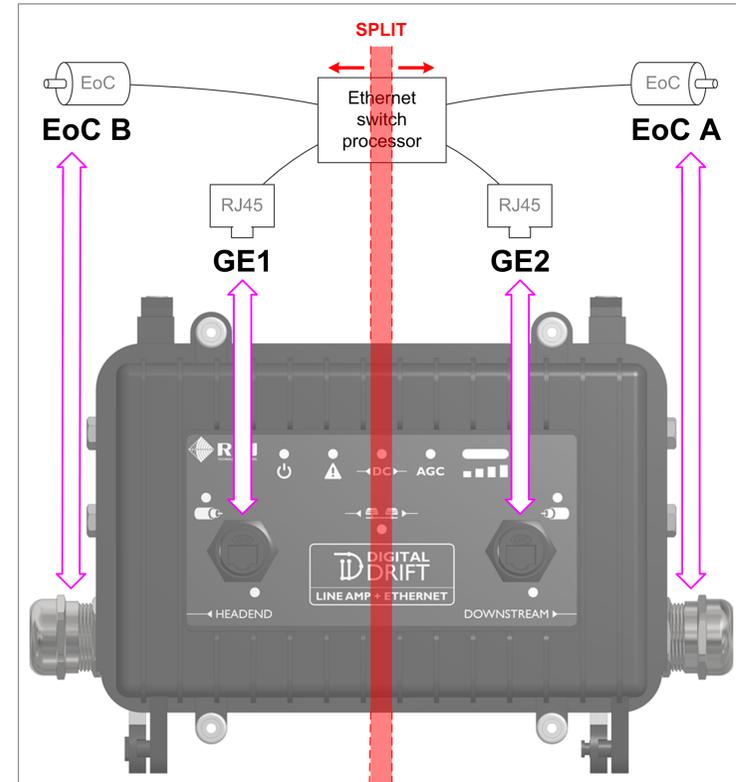
**Switch fabric split**  
(2 x 2-port switches)

**NOTE:** When an LAE's switch fabric is "split", VLANs are disabled and the device operates as two independent 2-port unmanaged switches, transparent to VLANs.

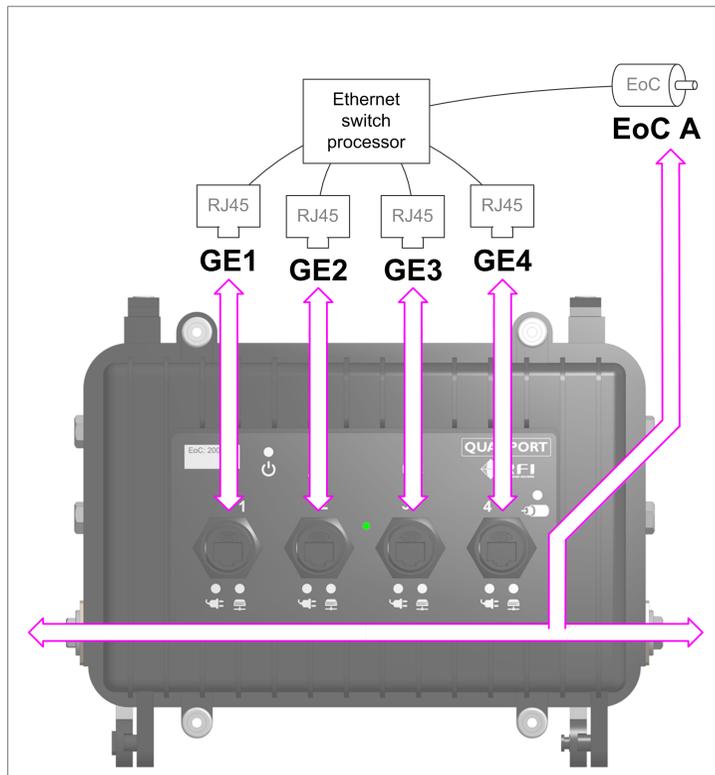
**EoC Pass-through mode**  
(1 x 5-port switch)

The QuadPort2 has five Ethernet ports, which always operate as a single switch fabric. An internal slide switch selects whether the EoC port operates in "End of line" or "Pass-through" mode.

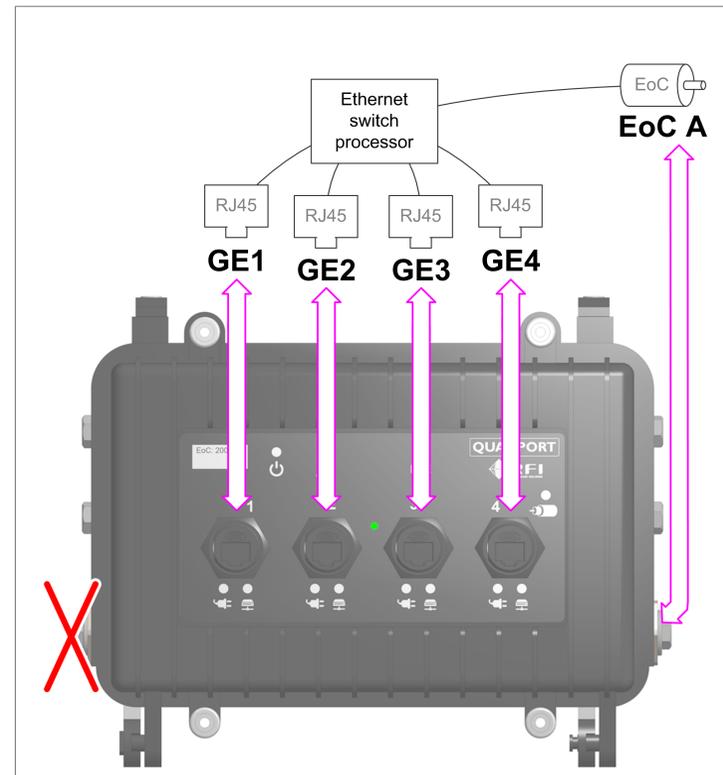
**EoC End of line mode**  
(1 x 5-port switch)

**NOTE:** DDLFS-QP2-V75 devices always operate the EoC port in "Pass-through" mode.

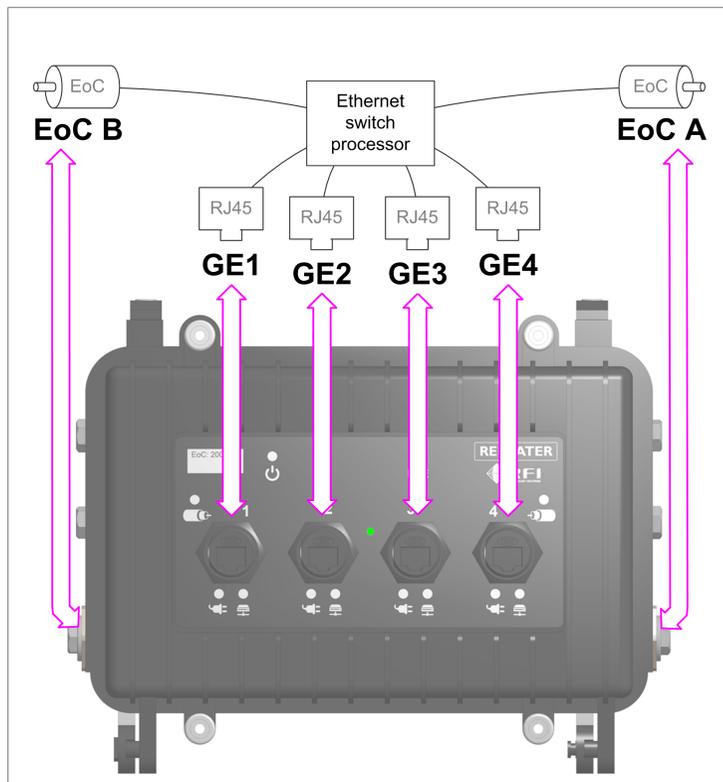
**EoC Pass-through mode**  
(1 x 6-port switch)

The Repeater2 has six Ethernet ports, which can operate as a single switch fabric, or as two independent 3-port switches.

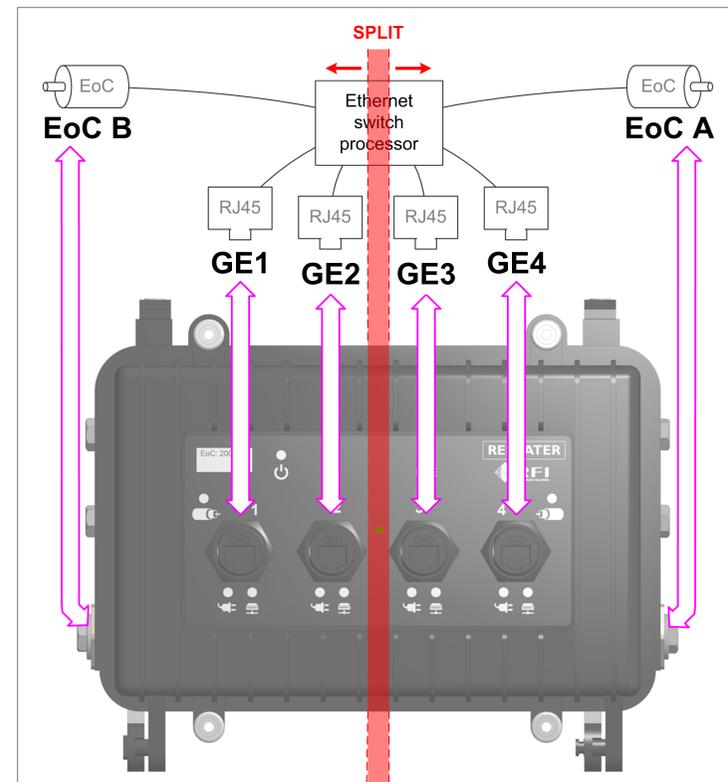
**EoC End of line mode**  
(2 x 3-port switches)

**NOTE:** When an RP2's switch fabric is "split", VLANs are disabled and the device operates as two independent 3-port unmanaged switches, transparent to VLANs.

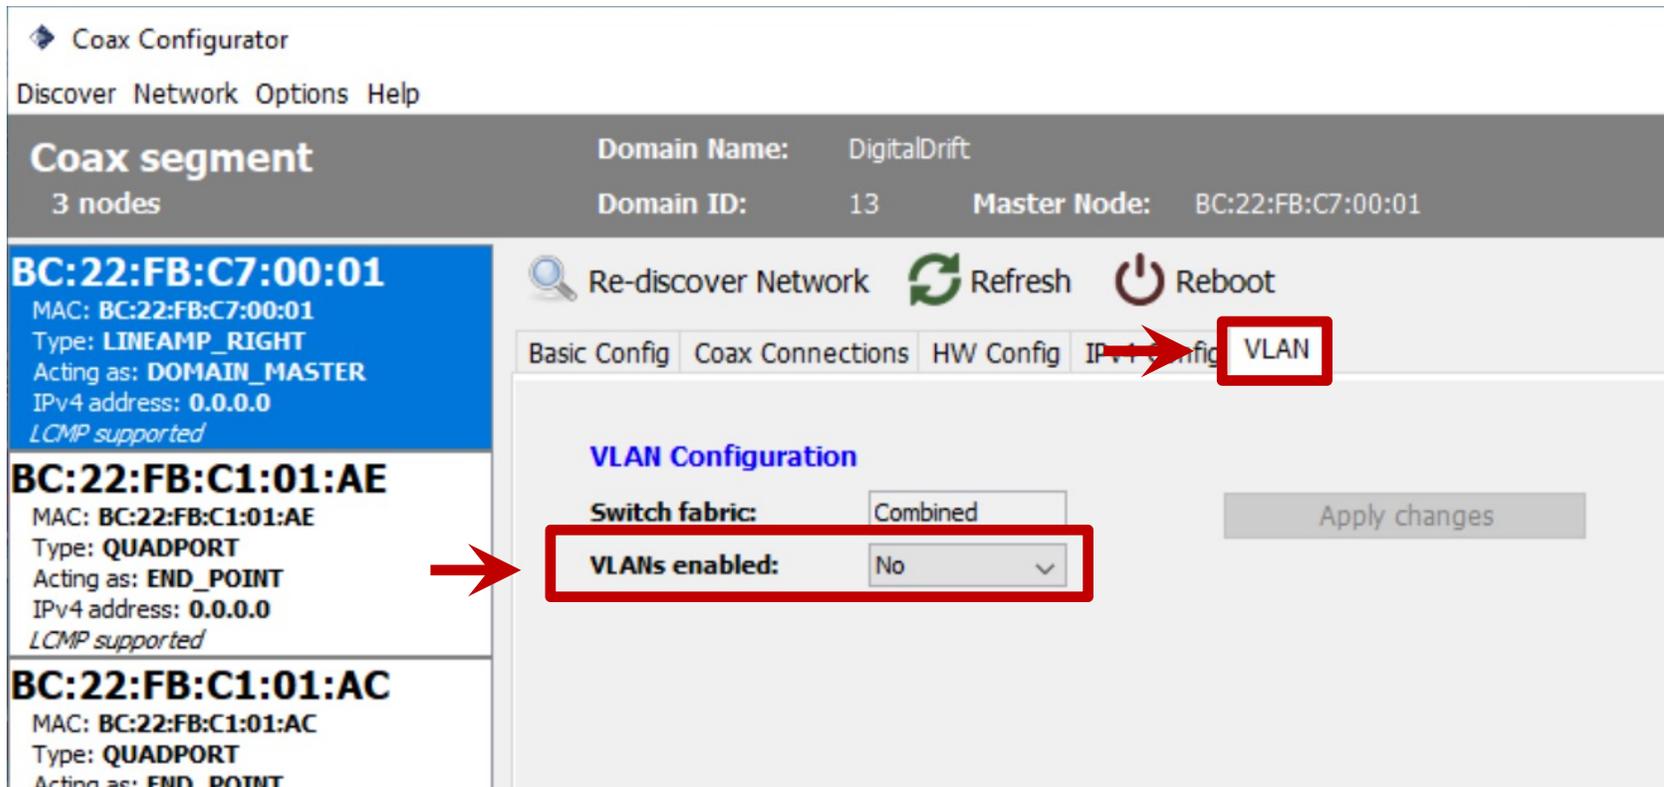
VLANs are configured via the CoaxConfigurator, accessing the EoC\_A management processor. By default, VLANs are disabled.

The screenshot displays the Coax Configurator interface. On the left, a list of nodes is shown, including BC:22:FB:C7:00:01 (LINEAMP\_RIGHT, DOMAIN\_MASTER) and BC:22:FB:C1:01:AE (QUADPORT, END\_POINT). The main area shows the 'VLAN Configuration' page with the following settings:

- Switch fabric: Combined
- VLANs enabled: No

The 'VLANs enabled' dropdown is highlighted with a red box, and a red arrow points to it from the left. Another red box highlights the 'VLAN' tab in the navigation menu, with a red arrow pointing to it from the left.

**NOTE:** When VLANs are disabled, the device is transparent to VLANs, meaning that it will pass tagged and untagged frames between all of the switch's Ethernet ports.

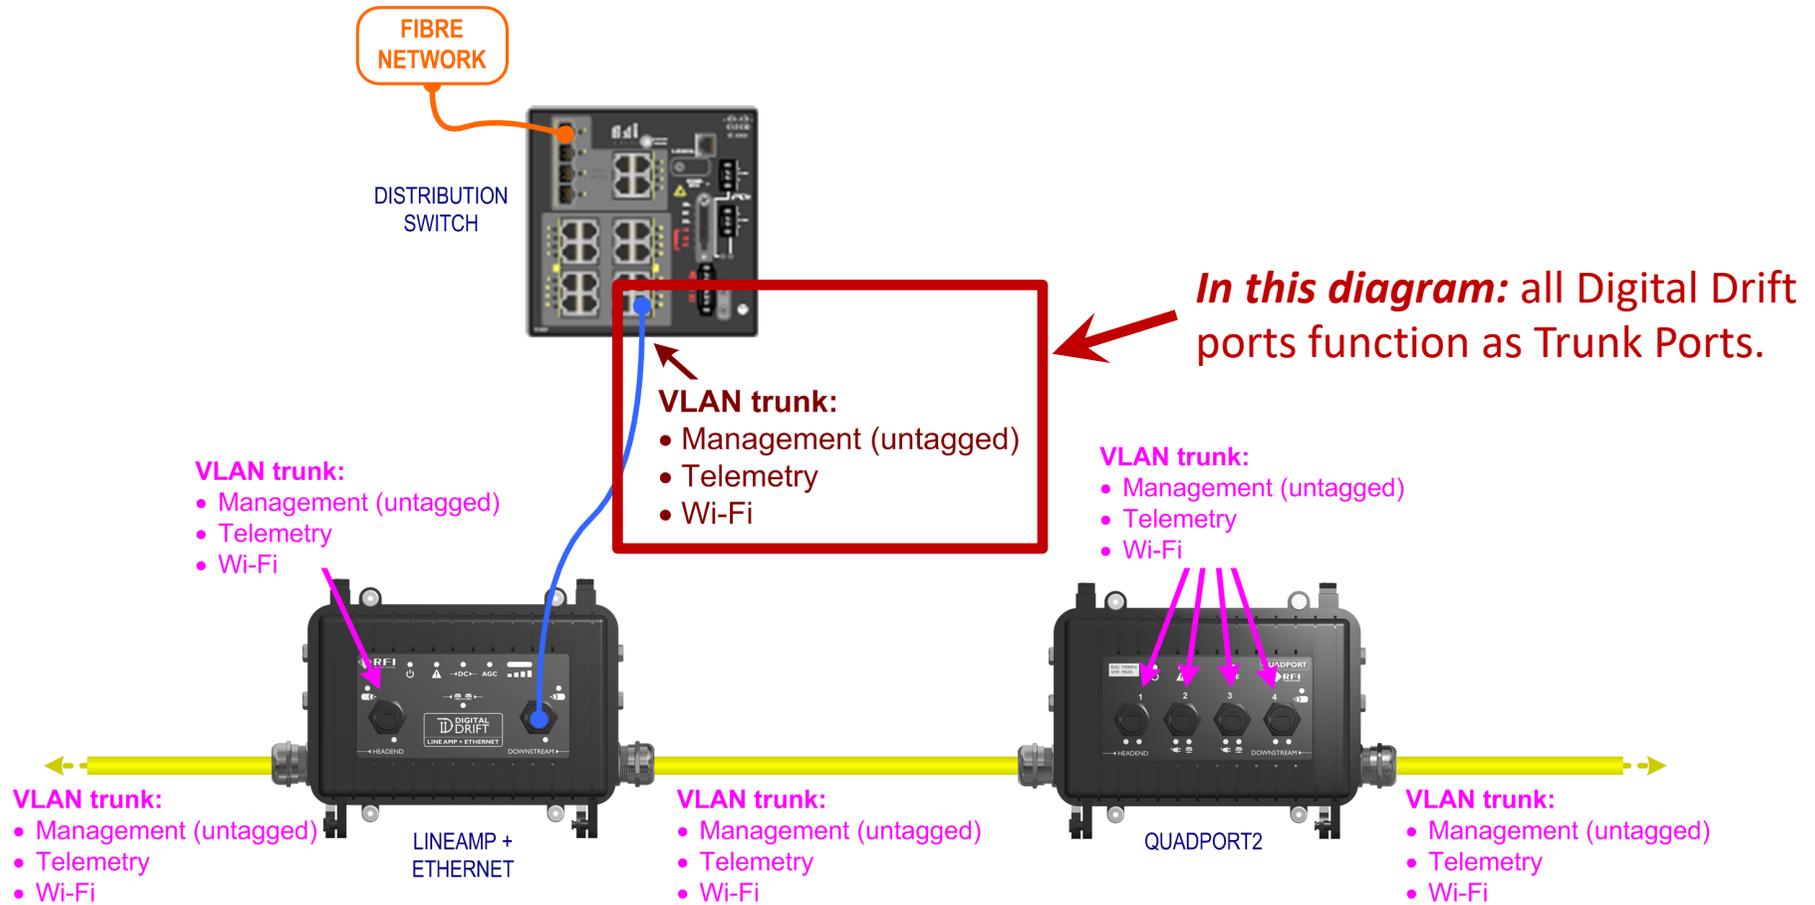
If the uplink is a Trunk port for a set of VLANs, all downstream Digital Drift ports also act as Trunk ports for that set of VLANs.

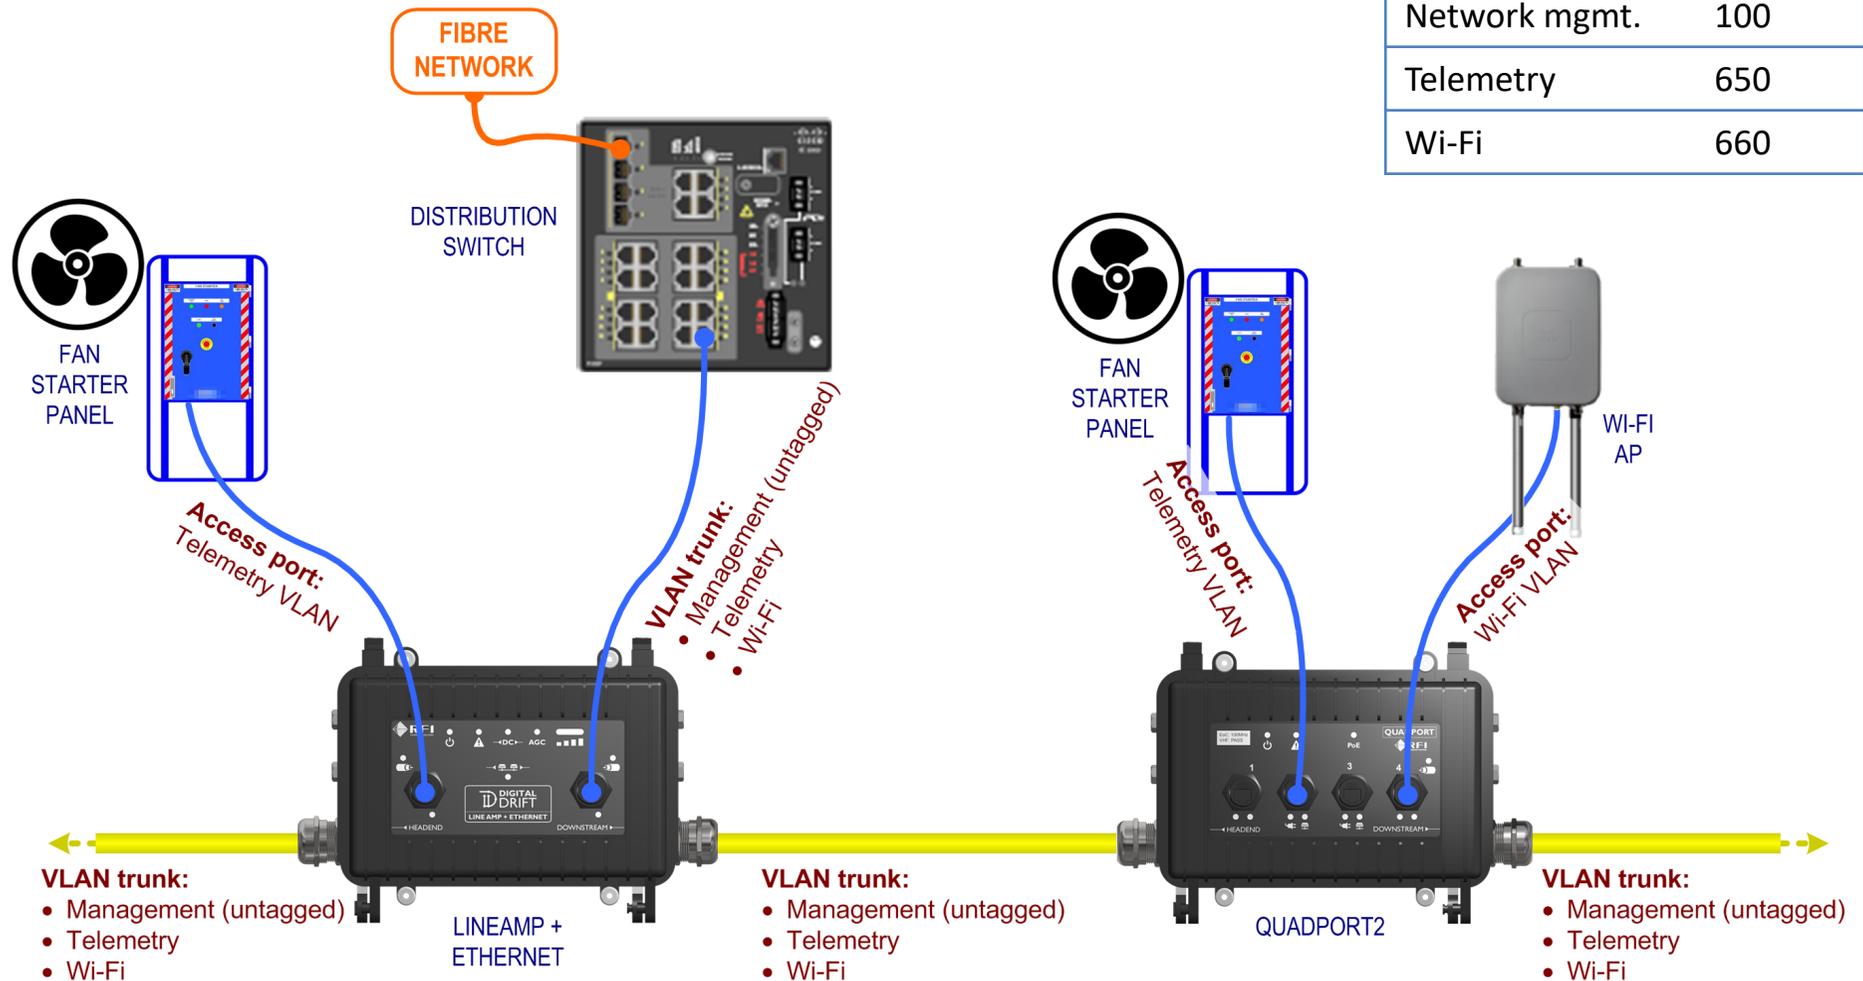
The desired state is illustrated below.

VLAN name	VLAN id
Network mgmt.	100
Telemetry	650
Wi-Fi	660

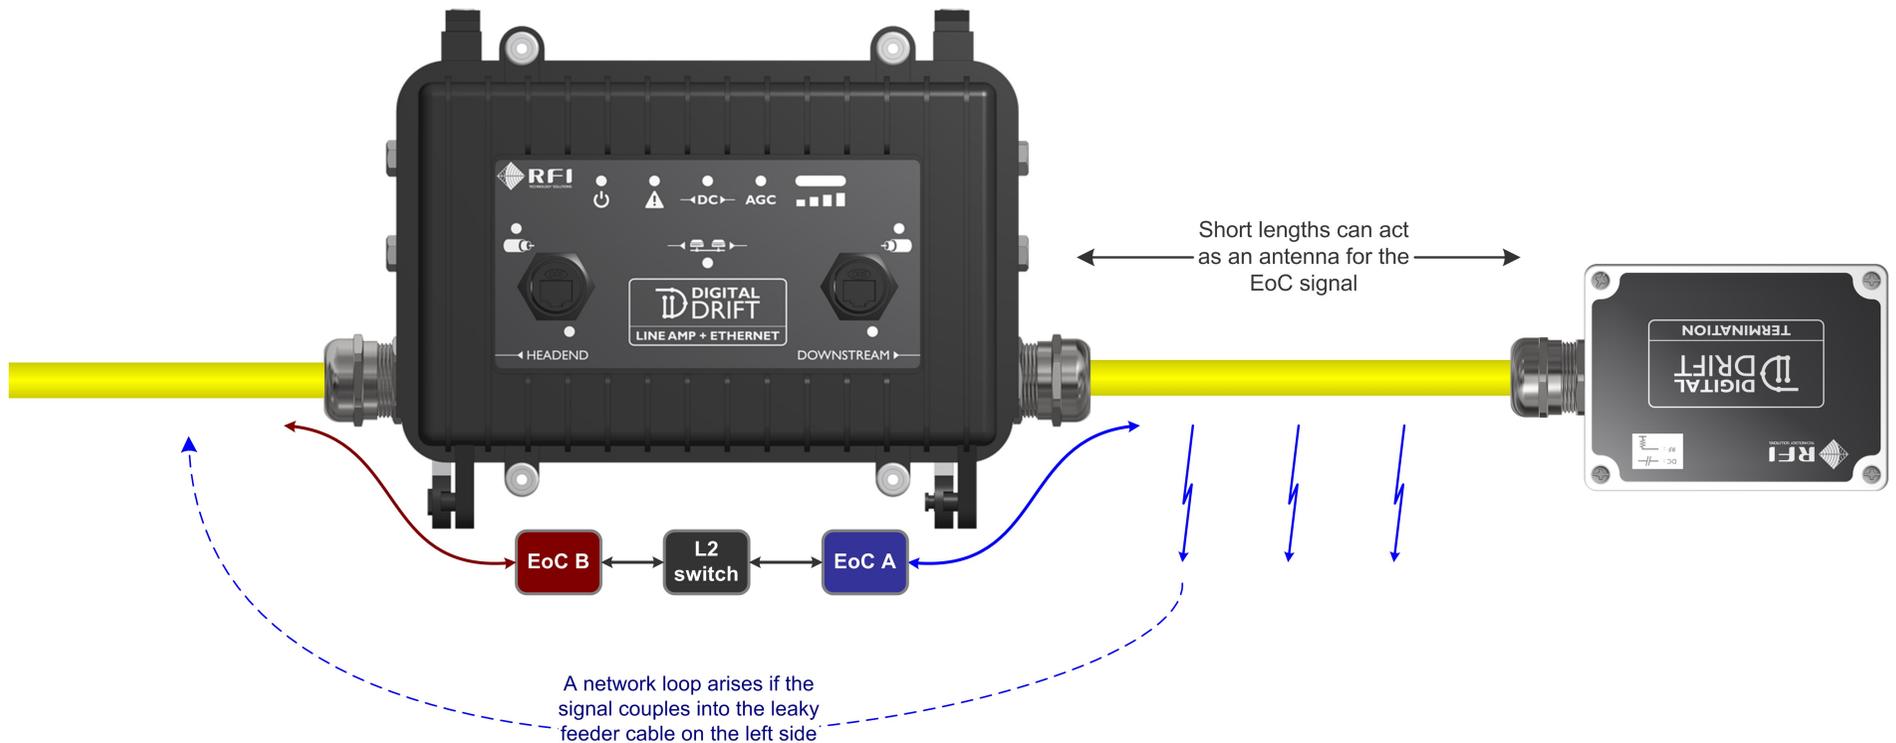
When LineAmp+Ethernet and Repeater2 devices are operated on leaky coaxial cable (LCX), there are situations where the LCX acts as an antenna, which causes the left and right side EoC interfaces to link up with each other.

v3.10 firmware reduces the EoC signal’s default TX power & lowers the RX AGC ceiling on LineAmp+Ethernet and Repeater2 devices.

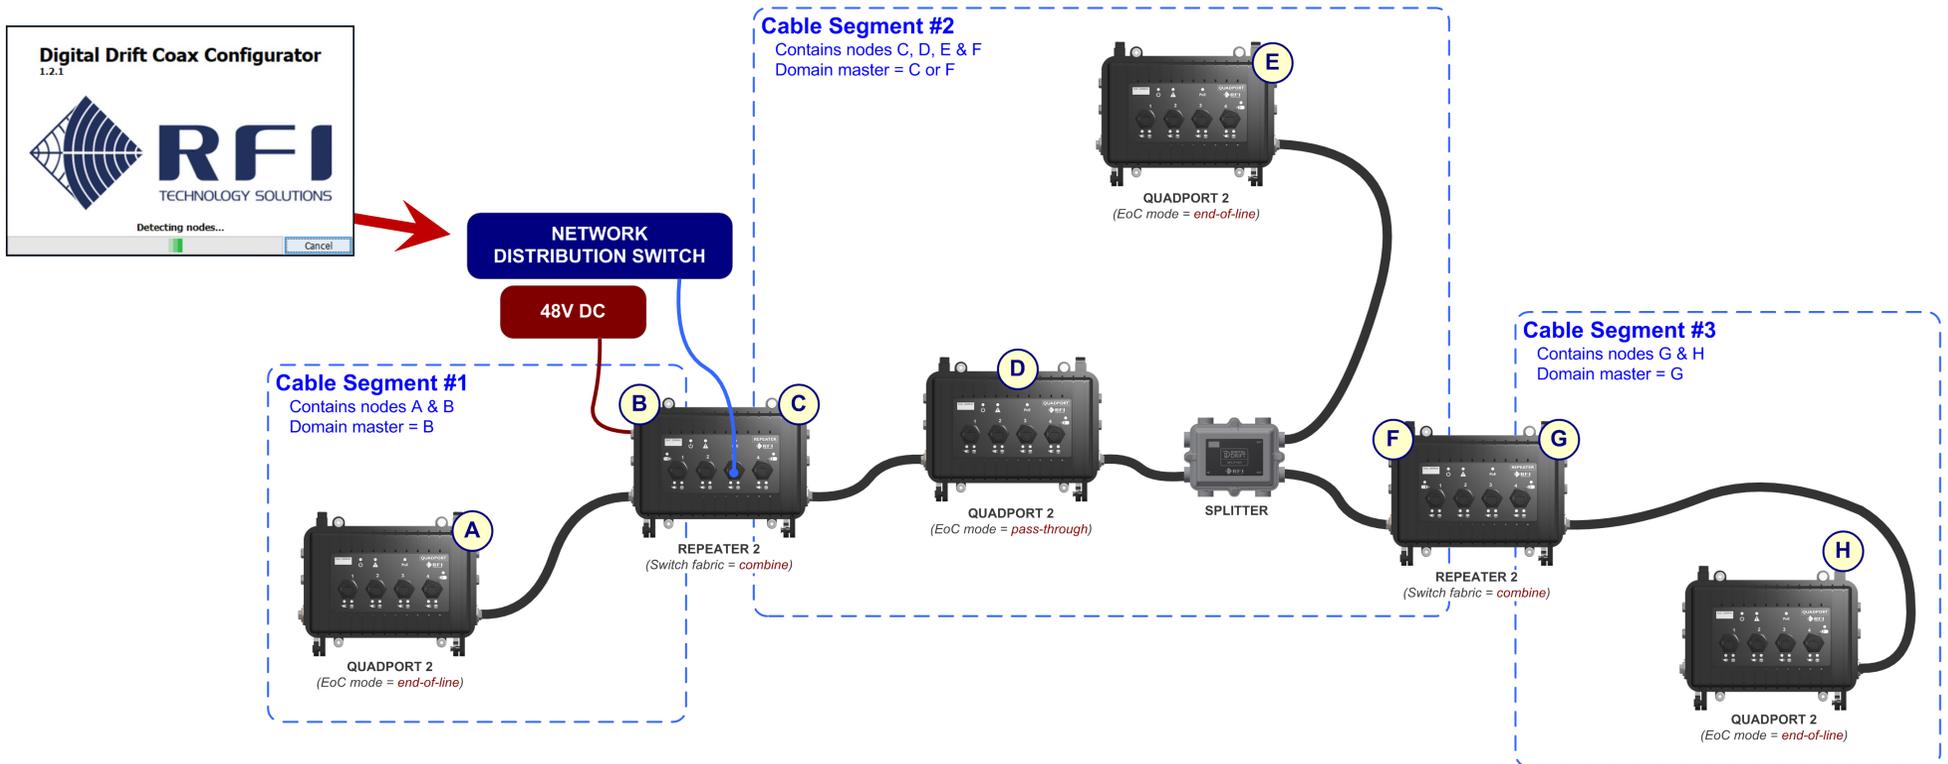
Remote coax. segments can now be interrogated by the CoaxConfigurator without needing to physically connect to an RJ45 port on that coax. segment.

Coax segments headed by Nodes B & C will be found by the CoaxConfigurator.

Coax segments headed by Nodes B, C & G will be found by the CoaxConfigurator.

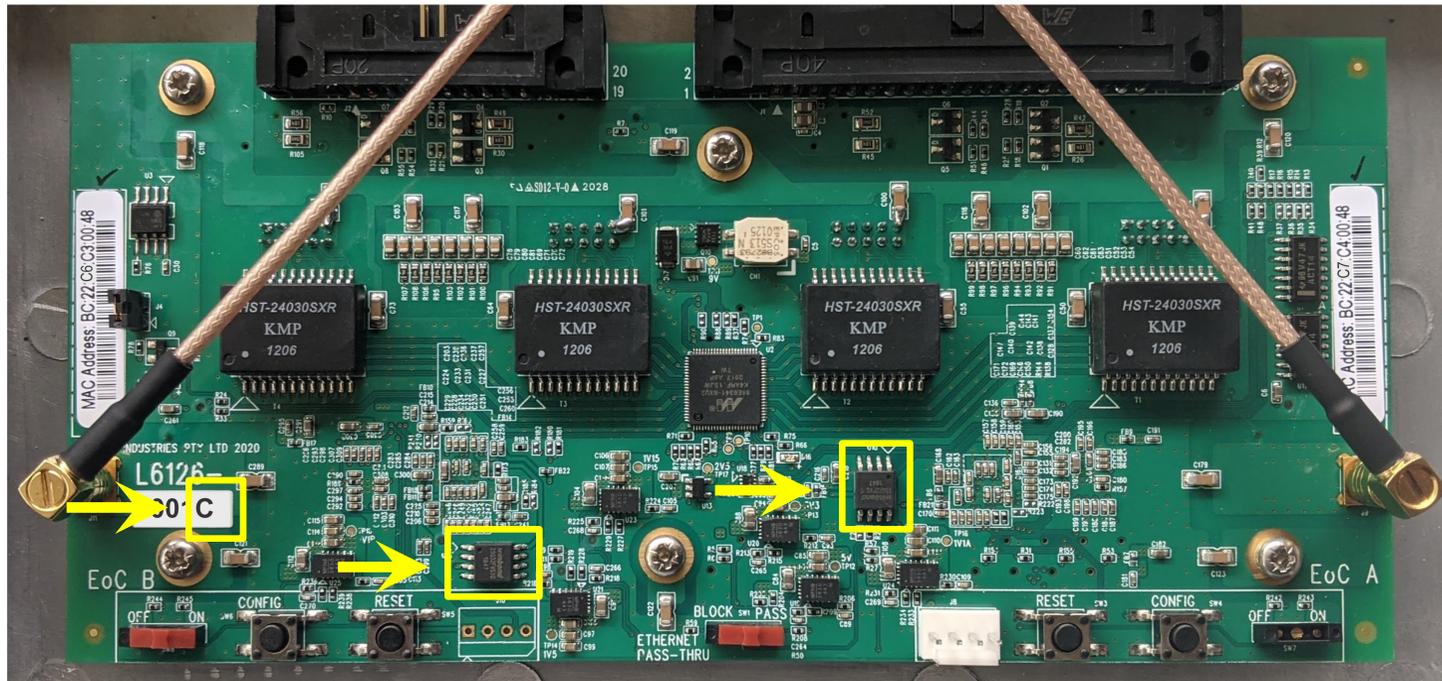
CCM320 based hardware manufactured after July 2022 may be fitted with 8MB flash chips. Firmware prior to v3.10 only supports 4MB flash chips.

**4MB flash variant**  
Hardware revision = **C**  
Flash chip(s) **unlabelled**

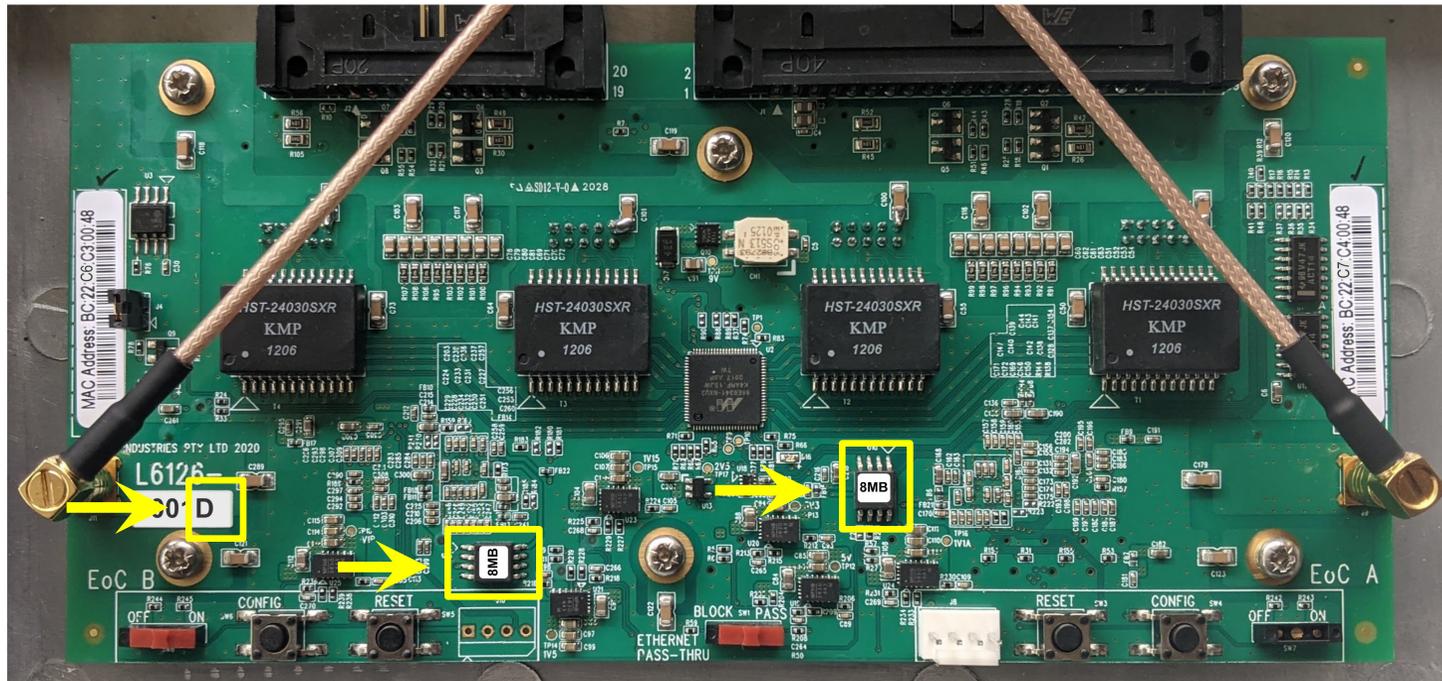
**8MB** flash variant

Hardware revision = **D**

Flash chip(s) **labelled as 8MB**

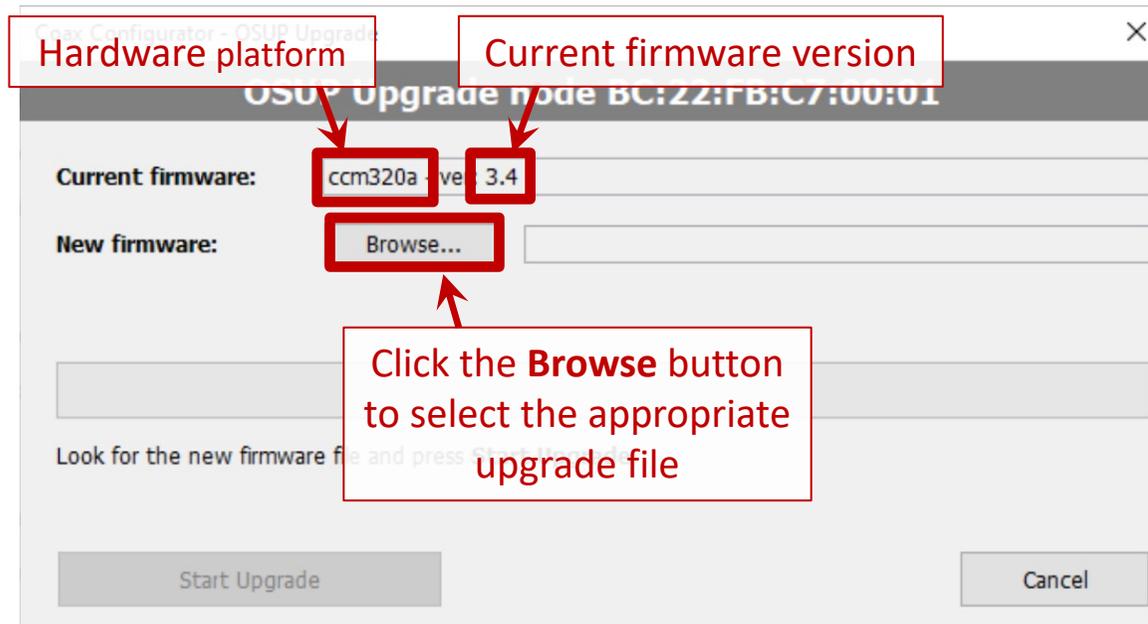
Select the upgrade file based on the hardware platform and flash size.

Hardware platform	Flash size	Upgrade file
ccm220	-	ccm220_p2mp_upgrade@3.10.bin
ccm320a	4MB	ccm320a_4MB_p2mp_upgrade@3.10.bin
	8MB	ccm320a_8MB_p2mp_upgrade@3.10.bin
ccm320b	4MB	ccm320b_4MB_p2mp_upgrade@3.10.bin
	8MB	ccm320b_8MB_p2mp_upgrade@3.10.bin

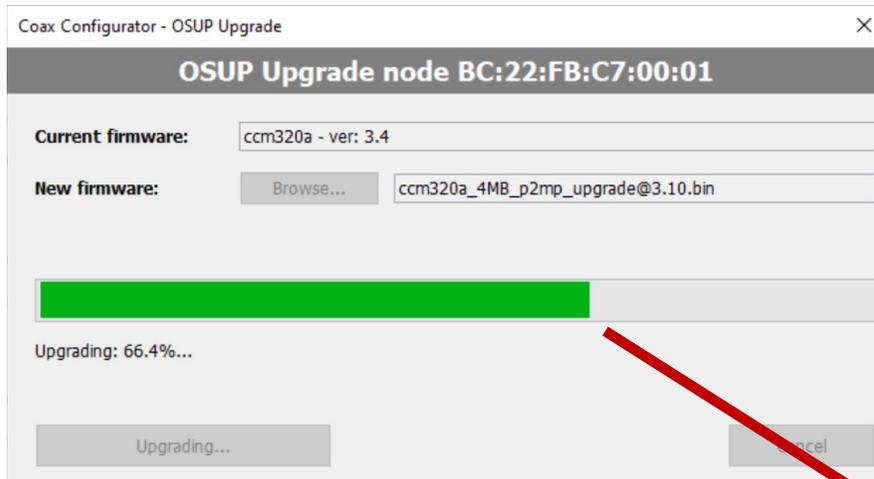
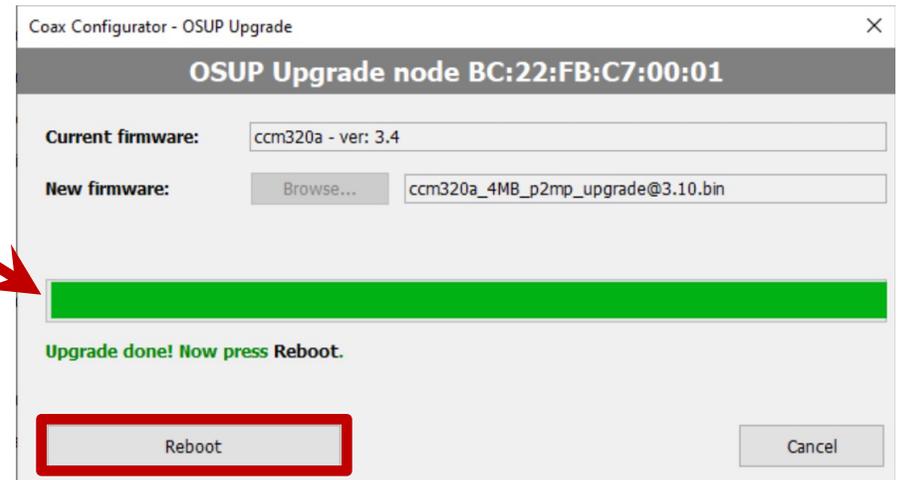
If a compatible upgrade file was selected, the upgrade will commence. Wait until the percentage bar reaches 100% and the Reboot button is displayed.

Click the **Reboot** button once the upgrade is done

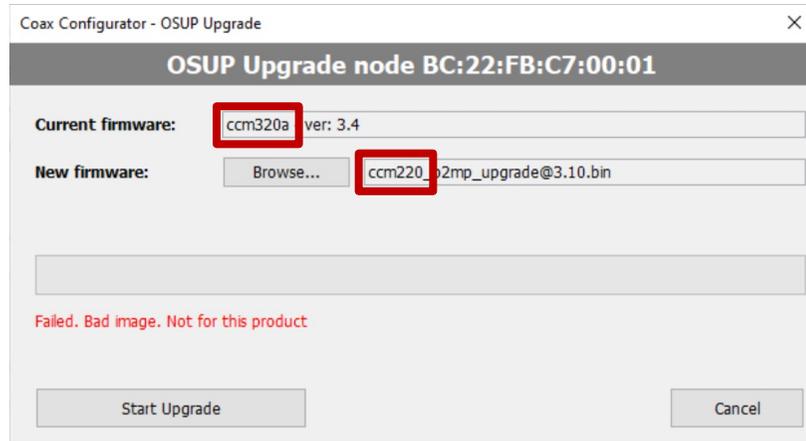
## Cause #1: Wrong hardware platform:

The screenshot shows the 'Coax Configurator - OSUP Upgrade' dialog box for node BC:22:FB:C7:00:01. The 'Current firmware' field contains 'ccm320a ver: 3.4'. The 'New firmware' field contains 'ccm220\_p2mp\_upgrade@3.10.bin'. A red error message at the bottom reads 'Failed. Bad image. Not for this product'. The 'Start Upgrade' and 'Cancel' buttons are visible at the bottom.

Try again with the upgrade file that matches the device's hardware platform.

There are two possible causes of the error message: **Bad image. Not for this product**

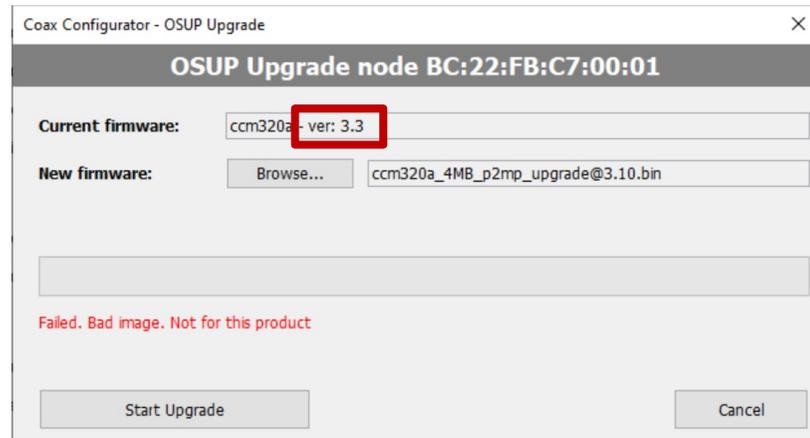
## Cause #2: Current firmware version is 3.3:

The screenshot shows the 'Coax Configurator - OSUP Upgrade' dialog box for node BC:22:FB:C7:00:01. The 'Current firmware' field contains 'ccm320a ver: 3.3'. The 'New firmware' field contains 'ccm320a\_4MB\_p2mp\_upgrade@3.10.bin'. A red error message at the bottom reads 'Failed. Bad image. Not for this product'. The 'Start Upgrade' and 'Cancel' buttons are visible at the bottom.
